# WEST HYLEBOS FOREST GAP ASSESSMENT

**West Hylebos State Park  
Federal Way, Washington**

**November 2007**

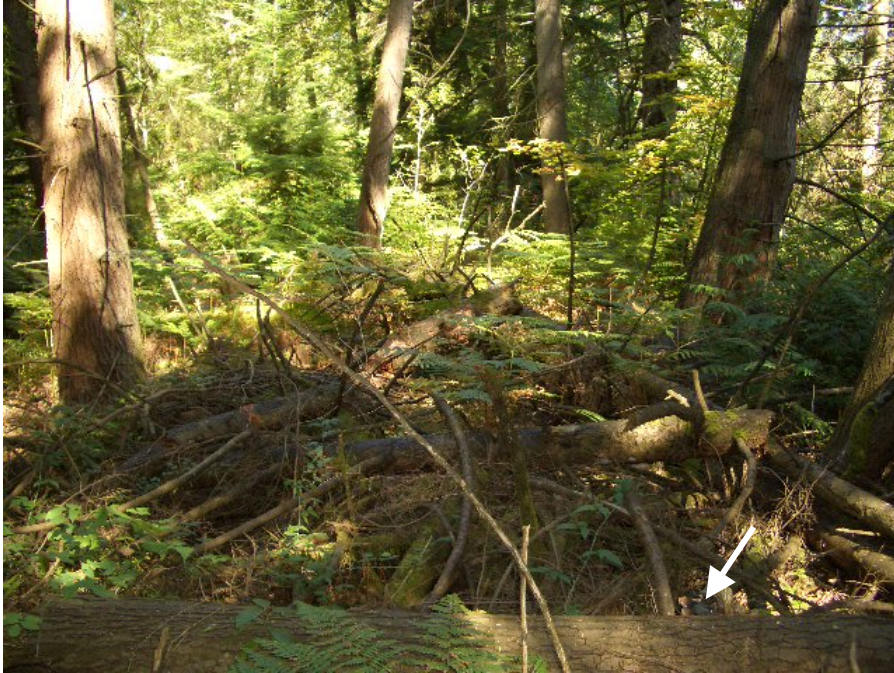
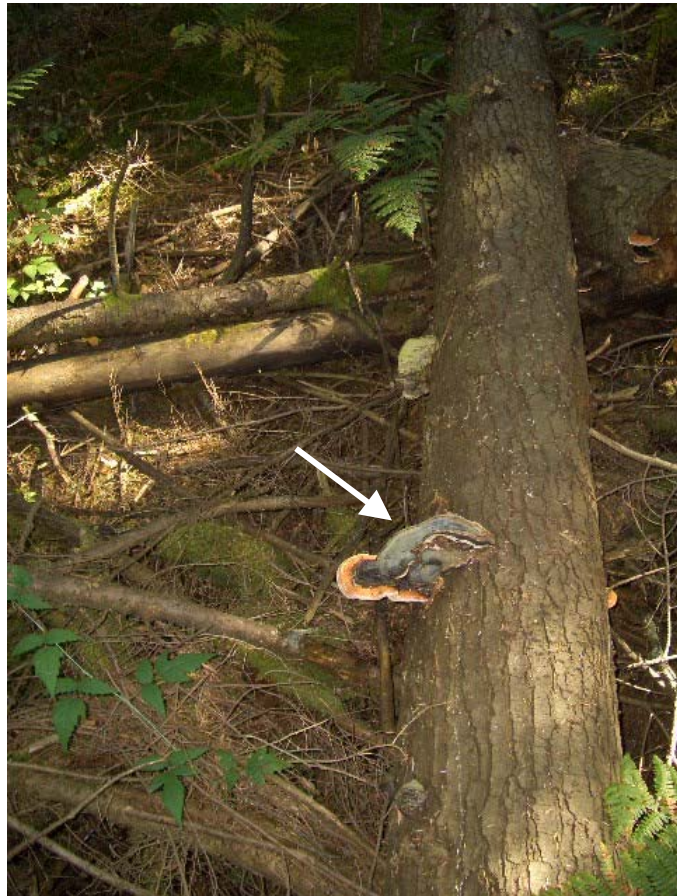
Above and right: Gap BW5 identified as a 'rot pocket' of hemlock trees affected by the root rot *Ganoderma oregonense* with basiocarps visible on standing and down trees. This gap is in a stand of almost exclusively hemlock trees with a sparse understory of cascara and vine maple, and bracken fern, dewberry, and false lily-of-the-valley in the groundlayer. This site is a mesic upland site.

1. **HIGH PRIORITY:** Control invasive species in interior areas of minimal invasion by removing all invasive plants found within identified gap sites. Complete removal should be achieved. The level of effort to accomplish this task should be relatively low and since no planting is recommended, creating a work plan and mobilizing a work crew should be straightforward. These sites include **Areas 1.2, 1.3, 2.2, 3.2, 3.3, 3.4, 5.4, 5.5, BW5.**

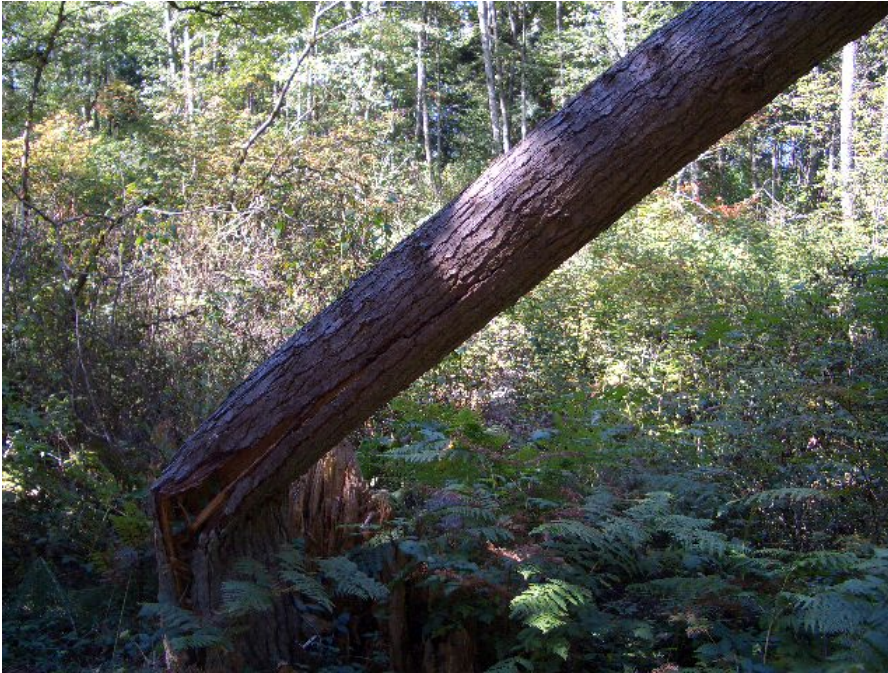
Above: Gap BW3 with a single down hemlock tree affected by *Armillaria spp.* The soils are saturated and surrounding vegetation includes a salmonberry thicket with skunk cabbage and lady fern in the groundlayer. Other canopy tree species are red alder and Sitka spruce.

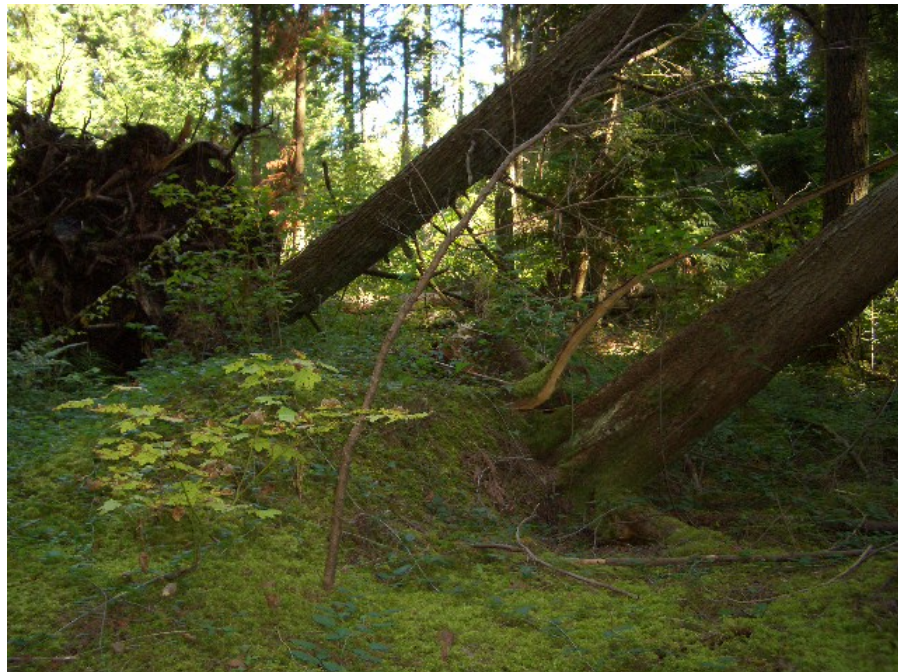
*Armillaria spp.* is a fungal pathogen that decays roots. The fungus grows in a mycelial fan between the wood and the bark. *Armillaria* is one of the most prominent decays of deciduous and coniferous forests. The decay weakens and kills the roots reducing the structure and strength of the tree. *Armillaria* spreads by spores from basidiospores or root to root contact. Good examples of *Armillaria* were found in gap 5.3.

Below: Gap 5.3 also with hemlock trees affected by *Armillaria spp.* This site has a mixture of hemlock, spruce, alder, and bigleaf maple in the canopy. Soils are saturated. Shrubs and herbs include red osier dogwood, vine maple, skunk cabbage, and lady fern.

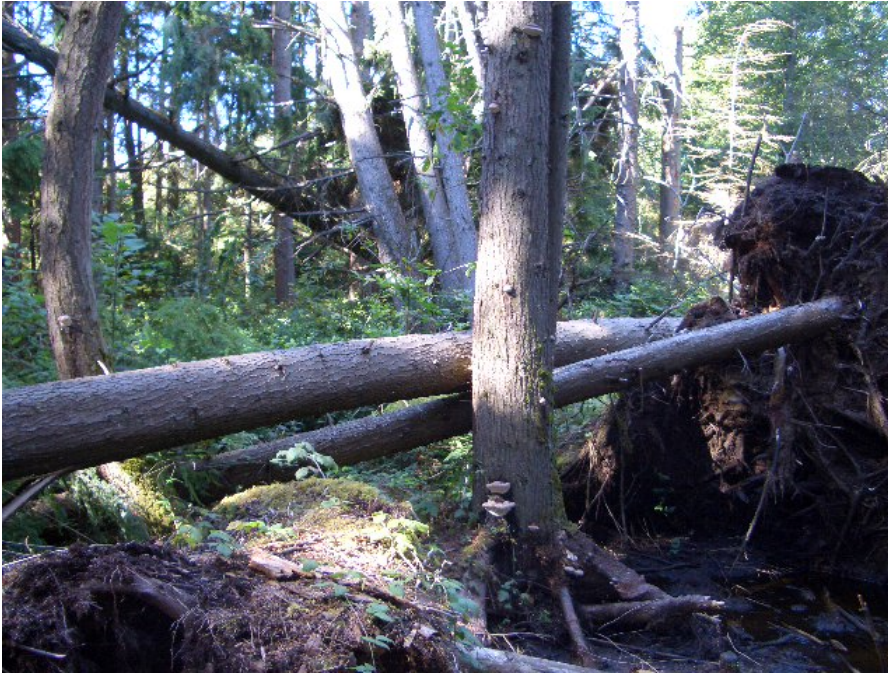
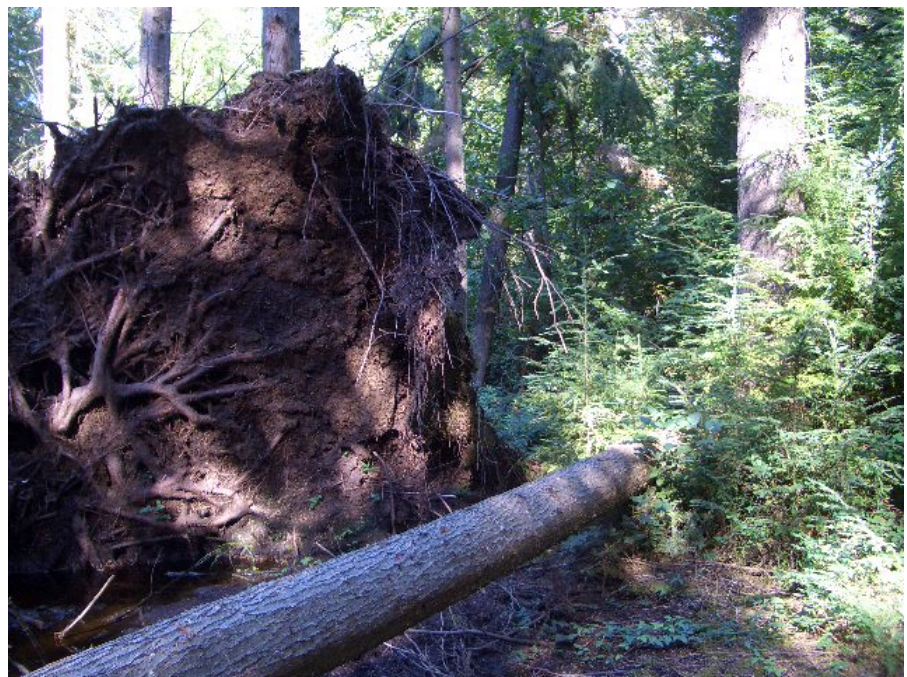
Above and below: Gap 2.2 with numerous down hemlock trees. Some of the trees have stem failures, some are windthrown with intact rootball. Some of the trees appear to be affected by rot but others are not. Hemlock regeneration is prolific as shown in the far right of the photo below. Site is hummocky with upland areas of hemlock and salal interspersed with pockets of standing water and skunk cabbage and spirea.

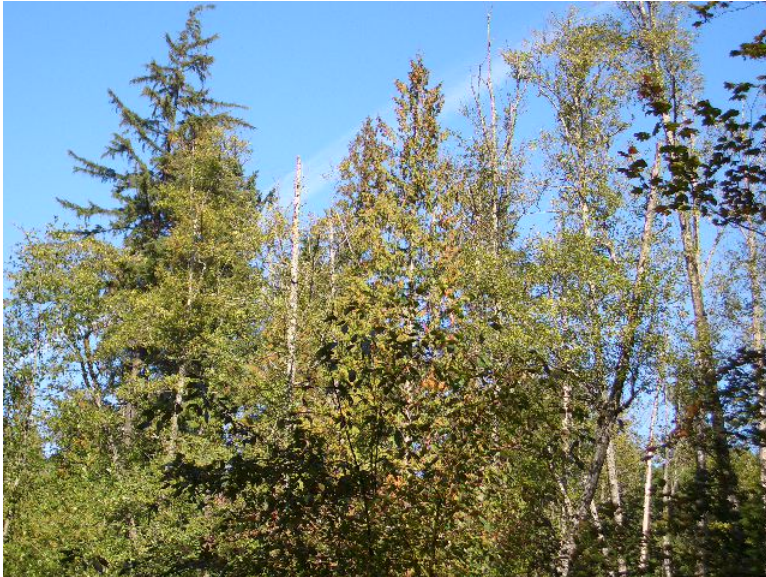
Top left: Gap 1.3 showing an area of sparse canopy that is typical in this area in the northeastern end of the boardwalk. The reason for the alder decline is not apparent. This area has lost numerous cedars, but also exhibits cedar regeneration. It is an extremely wet site with standing water in the gap area. Invasives are currently not a problem, but this site is adjacent to gap 1.4, which has a high incidence of Himalayan blackberry.

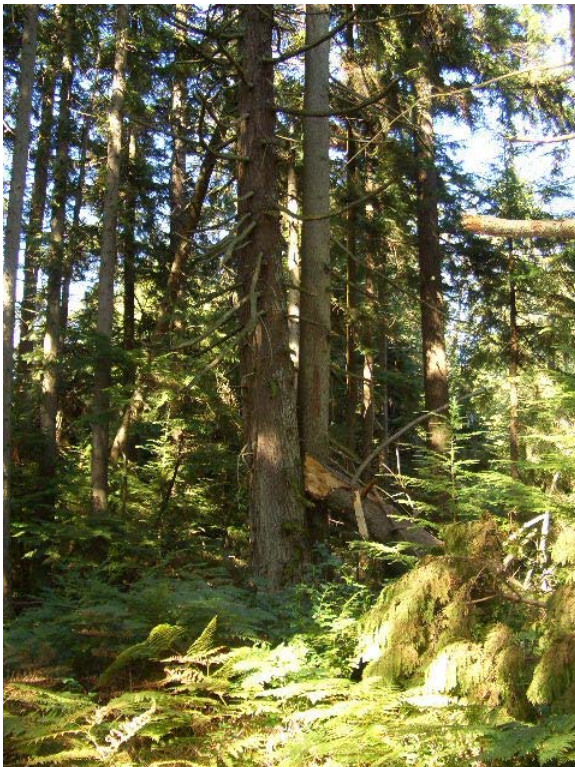
Below left: Gap BW7 with a hemlock stem failure unrelated to disease. There is regeneration of conifers (hemlock and cedar) and no invasives were noted. No action is recommended for this site.

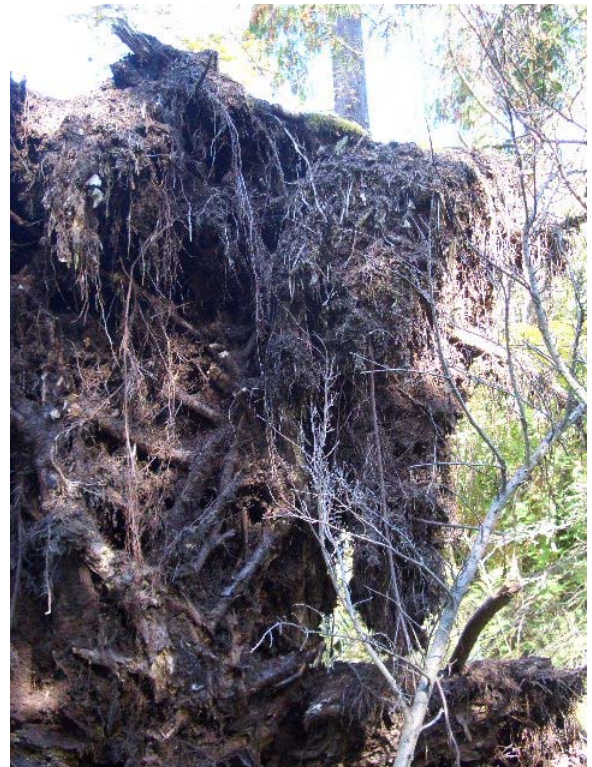
Below right: Gap 1.4 with a close-up of the fibrous roots of a windthrown cedar or hemlock. The roots are not damaged by root rot, and no other signs of fungal pathogens is evident. Trees have fallen due to the roots simply letting go in saturated soils.

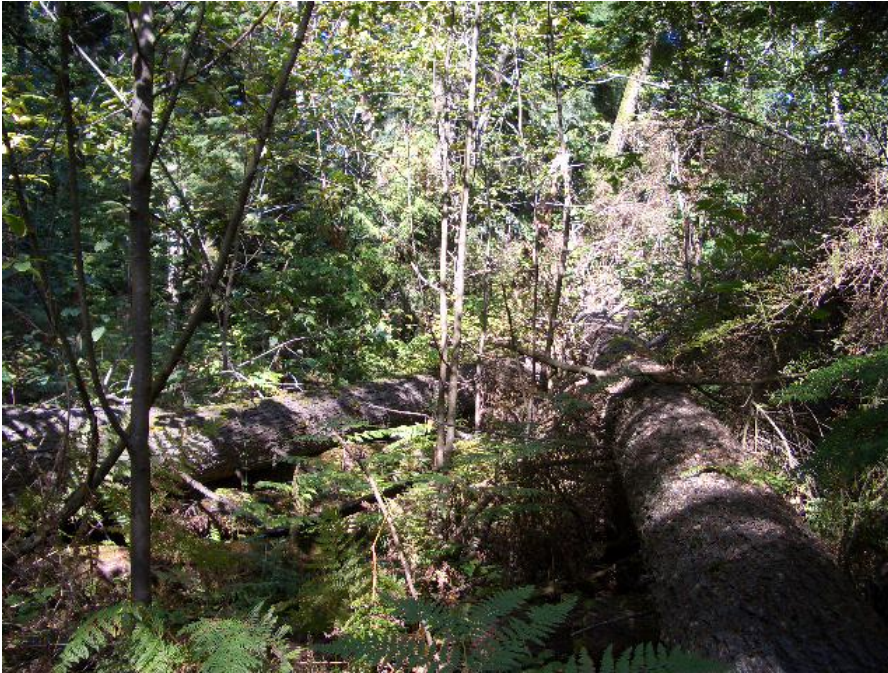
Above: Gap BW10 showing a “healthy mess” of down wood, regenerating young trees, and healthy understory of native species. This site has no invasives present, and due to the good condition of the vegetation in all layers, no action is recommended here.

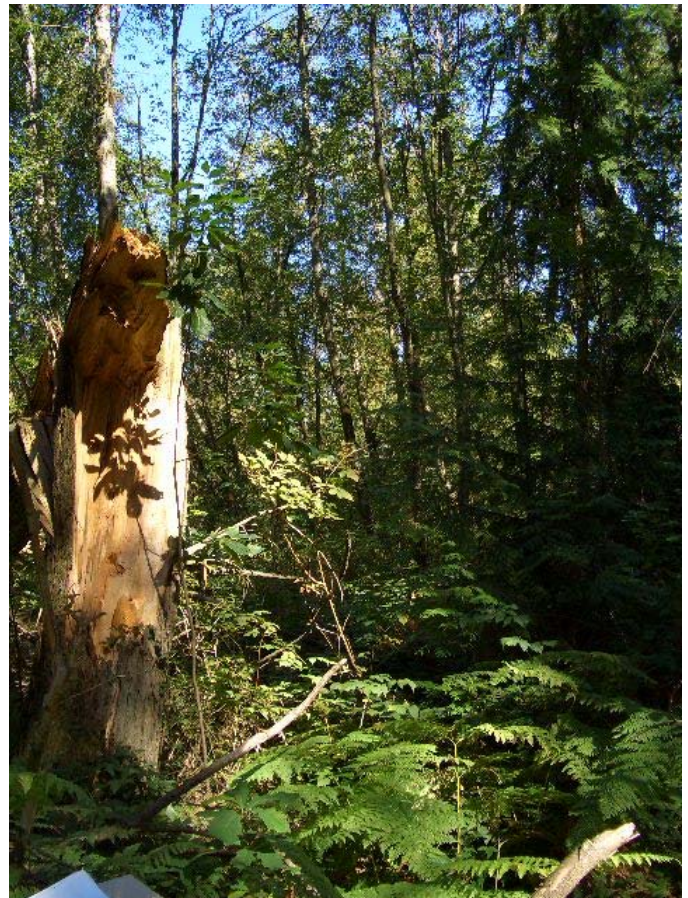
Right: Gap BW12 showing a site with some stem failures and some windthrown trees. There is evidence of a small rot pocket here, but this is not the cause of the majority of fallen trees. There is regeneration of all three canopy species that are present (alder, hemlock, cedar), no invasives are present, and the understory is diverse and healthy. No action is recommended here.
